# CHAGRIN RIVER RESIDENTIAL SLOPE MORELAND HILLS, OH

**Application:** Slope River Stabilization  
**Product:** TMax HPTRM + Anchors

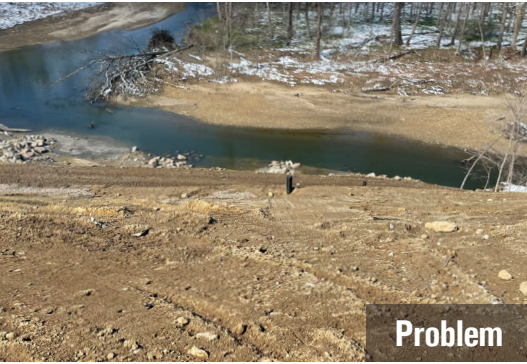
Problem

**Problem:** Situated in the greater Cleveland area, Moreland Hills, Ohio boasts rolling hills, beautiful views of the Chagrin River, and is a sought out neighborhood for residential developments. But with all of the hills and valleys, development of the land can be particularly challenging, especially when river flows and natural erosion of steep slopes are added factors. For these discerning property owners, the main goal of the project was to provide stabilization to the 1:1 (H:V) slope allowing for the development and construction of a residential home and an infinity pool at the top of the slope.

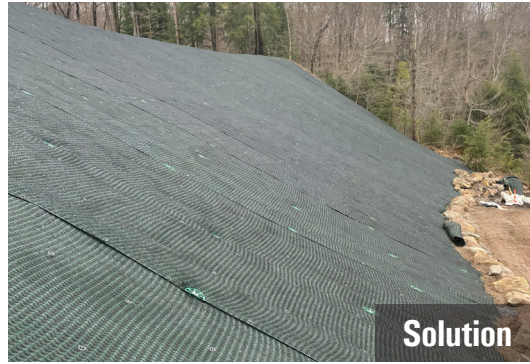
Solution

**Solution:** To begin the design process, the engineering lead at Cloonan Design Services worked closely with the technical teams at North American Green and its local distributor JMD Company, a division of Hanes Companies, to develop a slope stabilization solution for the project site. The property owners wanted to maintain a naturalized slope as a long-term design, and requested a stabilization solution that would allow native species to be planted. The stabilization process was started at the toe of the slope with the installation of concrete pylons and soil nails. The permanent infrastructure would help support the overall structural stability needed for the top of slope impact. The surface and sub-surface slope stabilization was addressed by the use of an Anchor Reinforced Vegetated System (ARVS). Specifically North American Green TMax, a permanent woven TRM was installed with percussion driven anchors and seeded. To finish the look, large boulders and stones would be placed to add a more natural look to the slope, while also helping to anchor the systems.

- TMax was installed along the slopes and secured with a combination of twist pins and PDAs.
- TMax HPTRM is optimized for steep slopes, with its UV stability and woven synthetic construction.
- The extended longevity of the product allows for permanent erosion protection and support of vegetation.

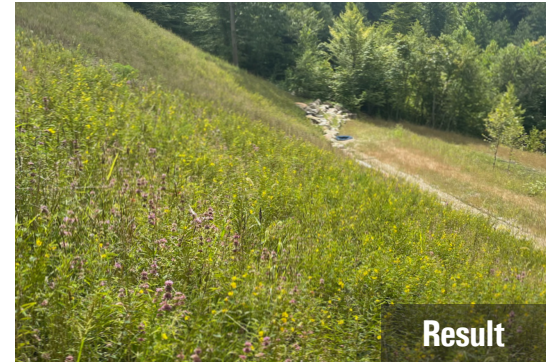
Result

**Result:** As the weather broke, the natural species seeded on the site, took hold, and the steep slope returned to a naturally vegetated river bank. This time though, the slope was protected from future river flood erosion. With the slope now stabilized, the landowners could continue the site development along the top of the bluff.
