## SANTA CLARA RIVER & COAST ACTON, CA

**Application:** River Stabilization  
**Product:** P550, ShoreMax, Anchors

**Site Issues:** Riverbank stabilization • Airport expansion •  
Waterway • Endangered wildlife species • Climate change

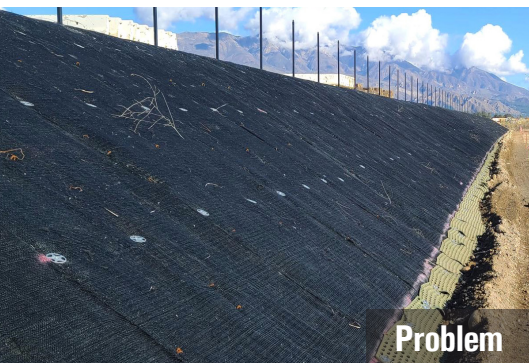
Problem

**Problem:** The Santa Clara River flows from Acton, CA to the Pacific Ocean near Oxnard. The problems began in 2005 when the rain-soaked Santa Clara River, running parallel to an airport, eroded a jetty adjacent to the runway. The runway was exposed and at risk for structural failure. When the river flooded and took with it 155 feet of the 2,650-foot runway in 2007, officials came to the aid of the airport by helping the owners obtain a grant from the Natural Resources Conservation Service (NRCS) to pay for repairs to the riverbank. As the Santa Clara River is one of the last relatively unaltered rivers in southern California, its restoration and conservation became a high priority area. The project scope included restoration of habitat for biodiversity recovery and critical ecosystem services, wildfire risk reduction and sea level rise adaptation. Additionally, the repair needed to restore hydrological function and habitat connectivity while planning for future functionality in the face of a changing climate.

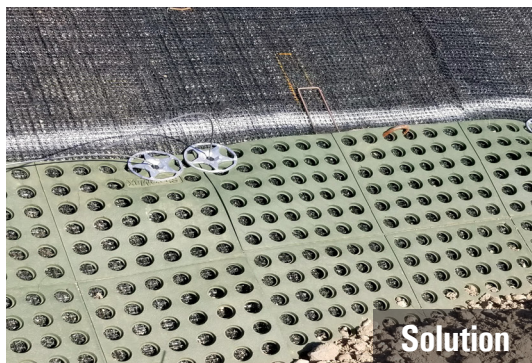
Solution

**Solution:** When it came to erosion control and surface habitat restoration, permanent erosion control products were analyzed to protect against the hydraulic forces. The Project Engineer developed a multifaceted solution utilizing North American Green permanent turf reinforcement mat: VMax P550, a flexible scour protection product: ShoreMax Transition Mat, and the Falcon Anchor Systems ground anchors: F80-X-Z percussion driven anchors. P550 was installed on the north side of the streambank slope with rebar staples to secure the matting. The ShoreMax transition mat was then placed to cover the P550 on the toe of the slope to normal water mark. The Falcon F80-X-Z anchors were then installed across the entirety of the slope. The site was not actively vegetated, but because of the nature of the product system, will naturally vegetate with native species as the site ages.

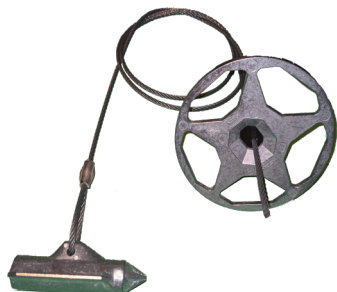
- ShoreMax (far left) is a UV stable, flexible revetment mat designed to provide scour protection while still allowing vegetation establishment through the mat.
- Falcon Anchors provided pull-out strength and support of the systems subsoils.
- The permanent longevity of the full product system allows for continuous erosion protection, a vegetated design, while being more cost effective than most hard armor systems.
